OPERATING EXPERIENCE WEEKLY SUMMARY

Office of Nuclear and Facility Safety

February 13 through February 19, 1998

Summary 98-07

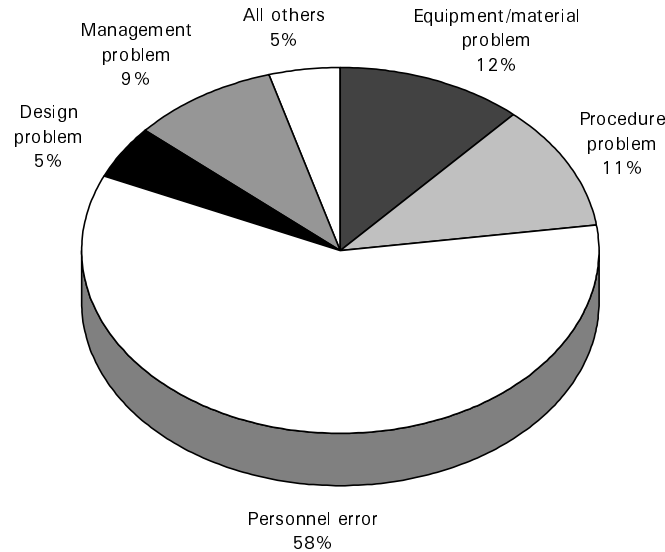
Figure 3-1. Direct Causes for Technician Conduct of Operations Violations¹

OEAF engineers searched the ORPS database for occurrences where technicians were involved in conduct of operations violations and found 699 occurrences. More than half of the occurrences had a direct cause of personnel error. Approximately 40 percent of the personnel error problems

resulted from inattention to detail, and approximately 45 percent resulted from a procedure that was not used or used incorrectly. Figure 3-1 shows the distribution of direct causes for technician conduct of operations violations.
